TECHNICAL REPORT HL-89-10

# NAVIGATION CONDITIONS AT GALLIPOLIS LOCKS AND DAM, OHIO RIVER

Hydraulic Model Investigation

Prepared for US Army Engineer District, Huntington  
Huntington, West Virginia 25701-2070

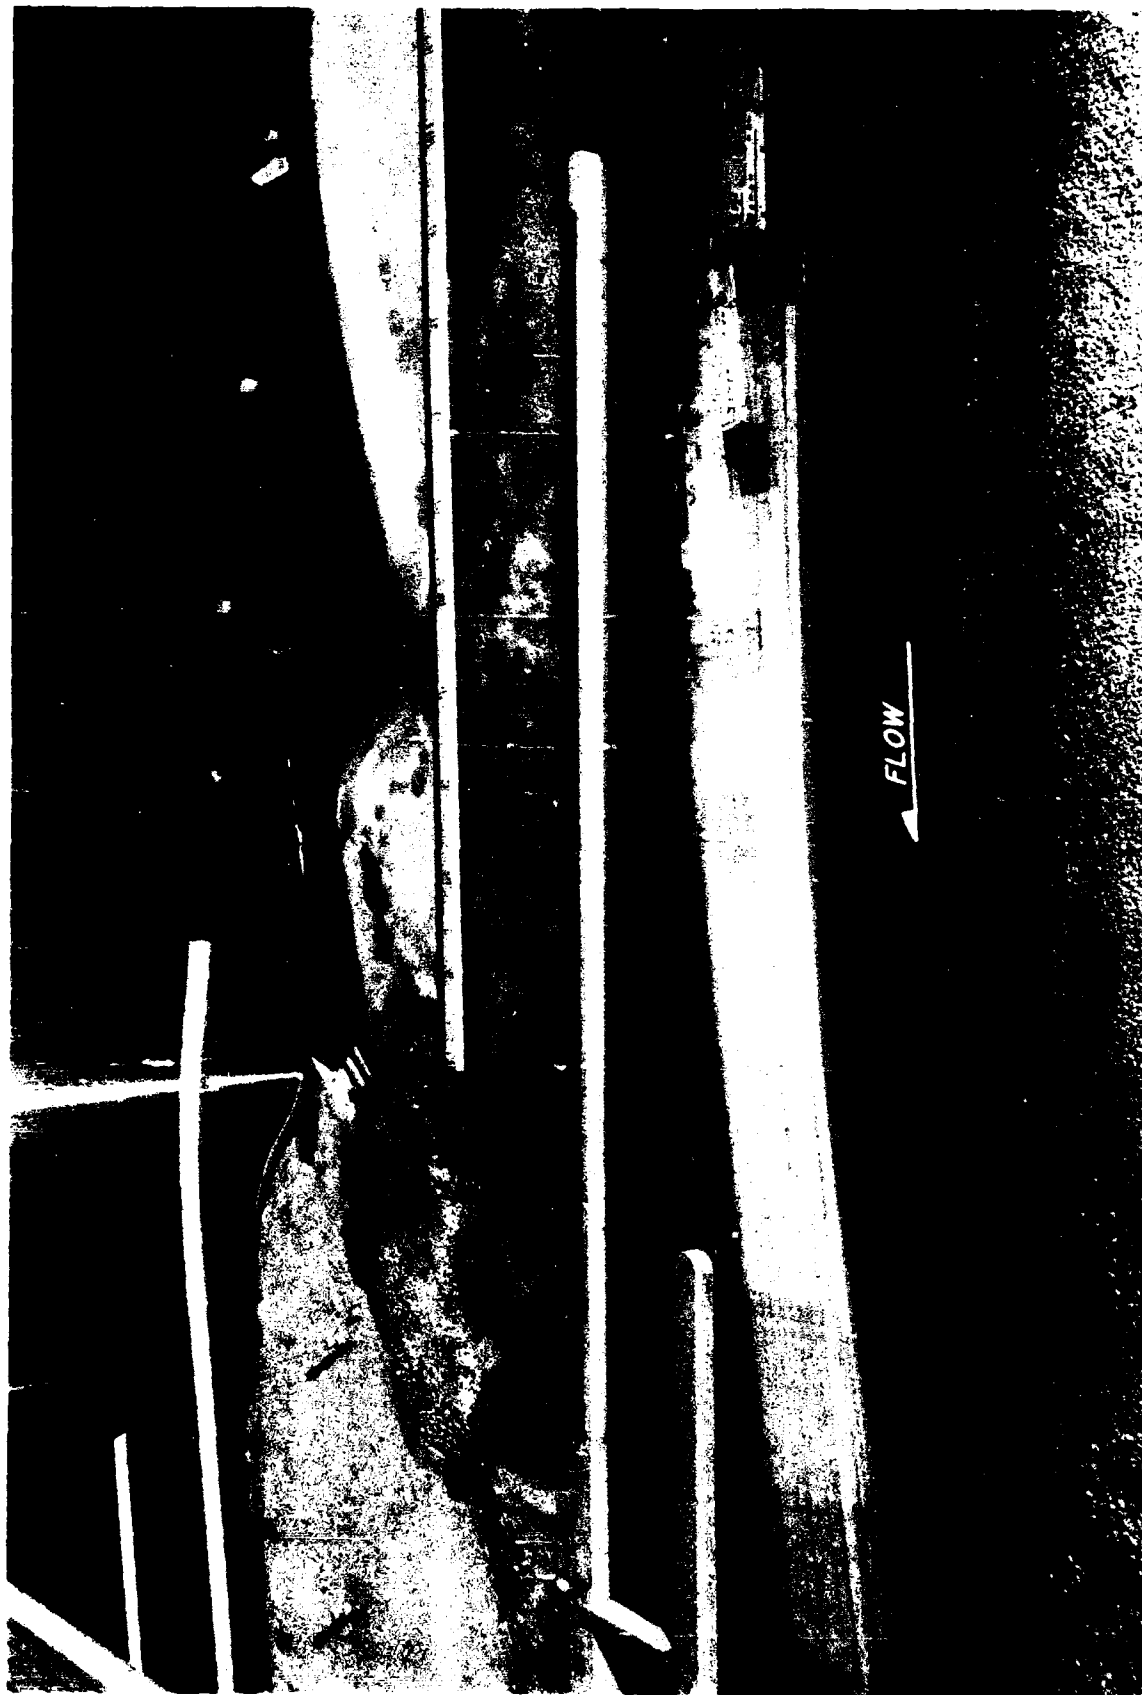
Photo 24. Plan E-7 modified, Scheme 5. Discharge 16,000 cfs, upper pool el 538.0, lower pool el 515.0.  
Note path of tow resulting from filling the 600-ft lock in 8 min

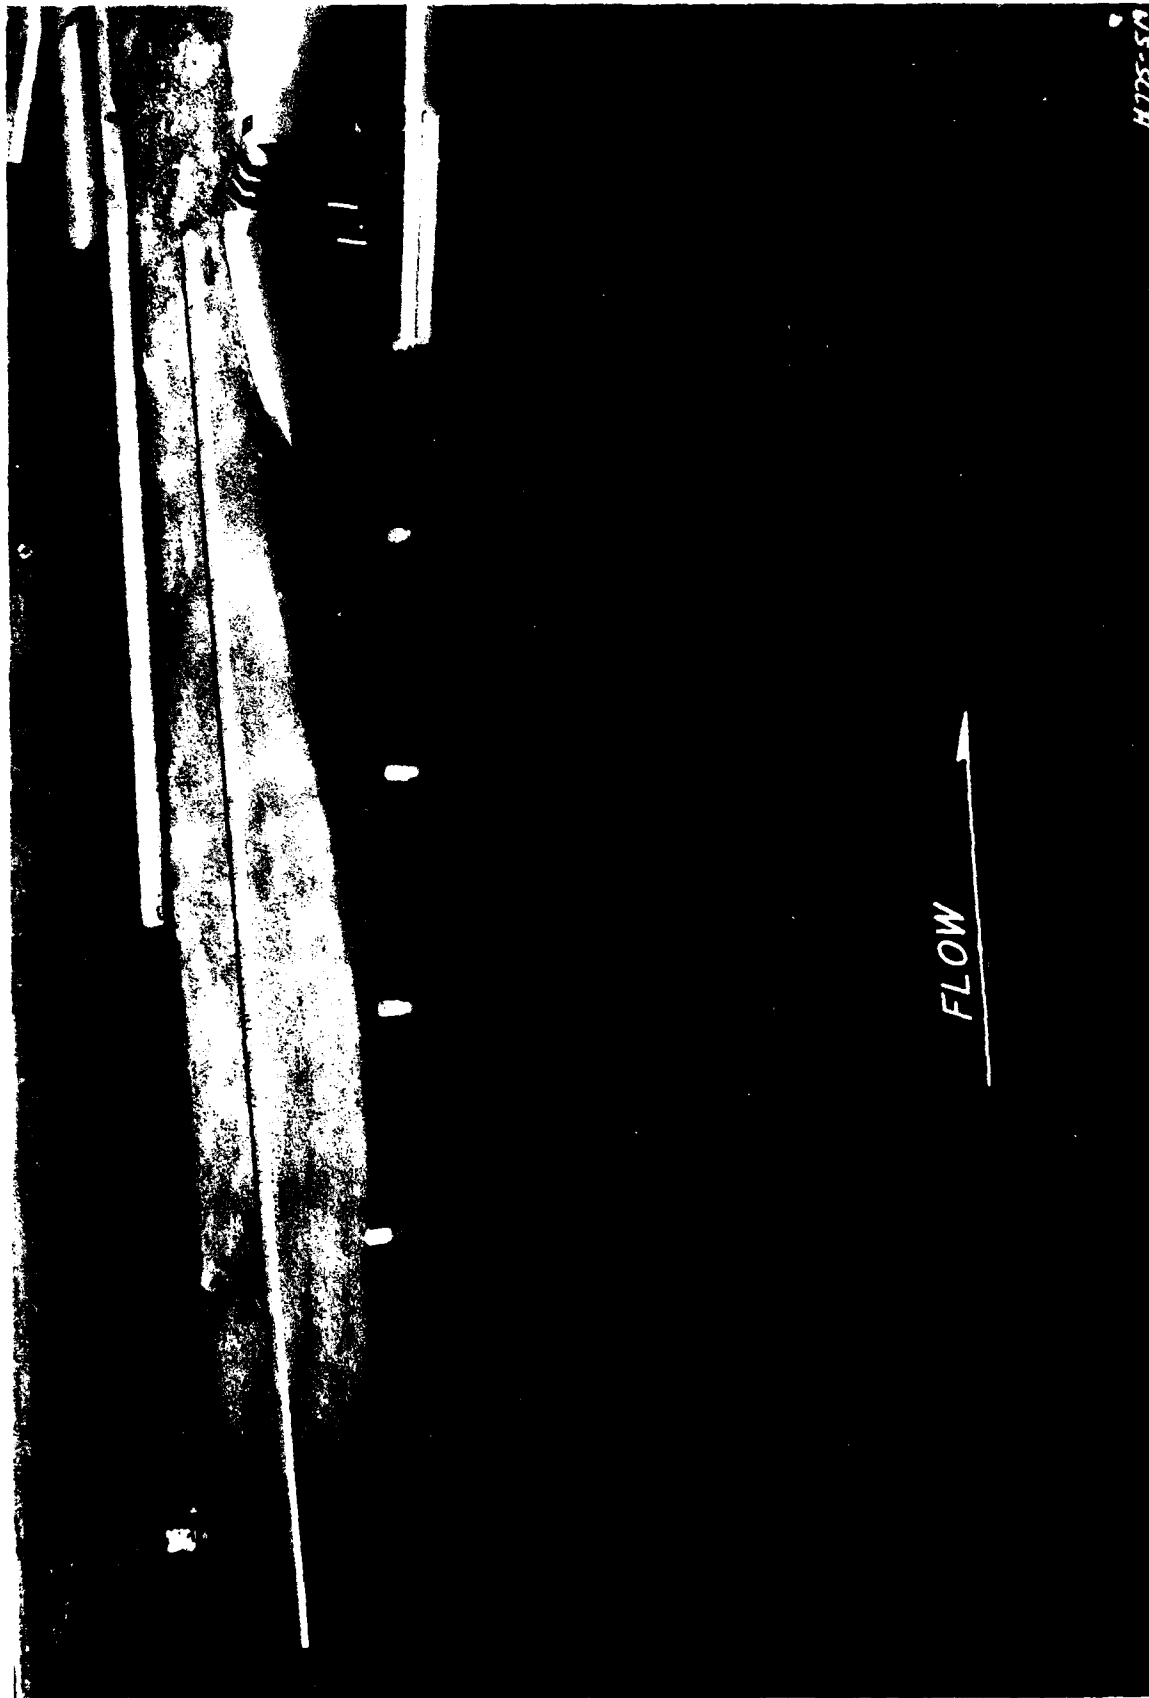
Photo 25. Plan E-9 modified, Scheme 6. Discharge 16,000 cfs, upper pool el 538.0, lower pool el 515.0. Current velocities in approach to filling intake resulting from filling both new locks simultaneously in 8 min

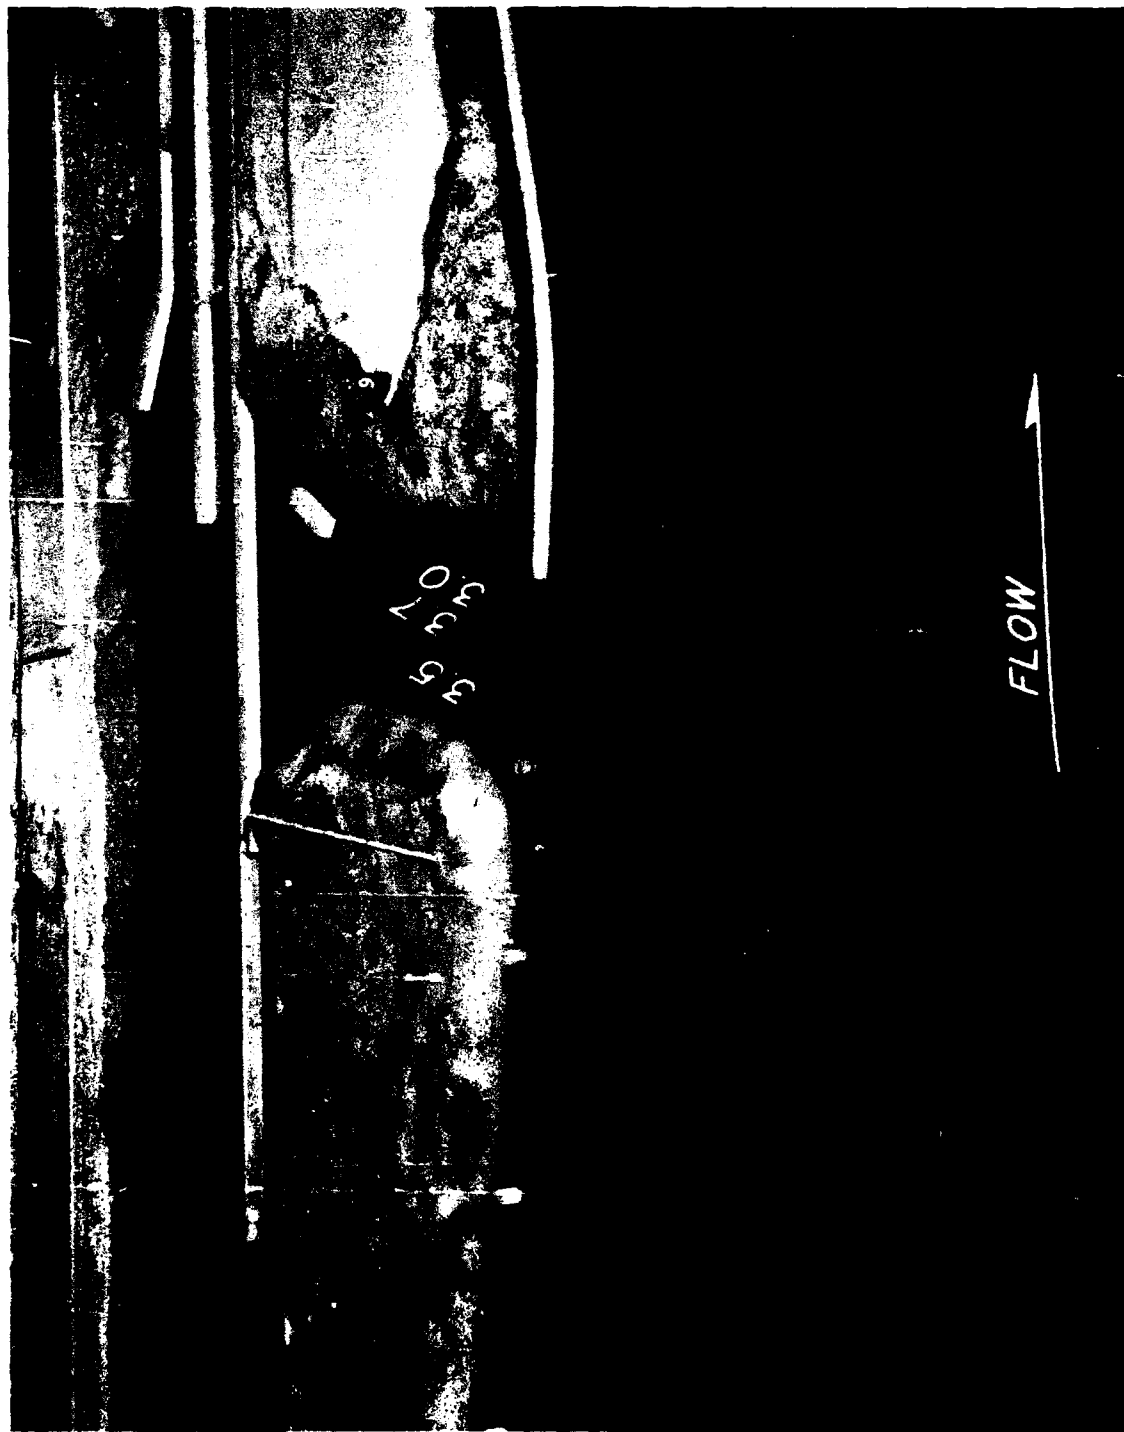
Photo 31. Plan E-10 modified, Scheme 9. Discharge 16,000 cfs, upper pool el 538.0, lower pool el 515.0. Current velocities and dye patterns in the approach to the filling intakes resulting from filling both new locks simultaneously in 8 min

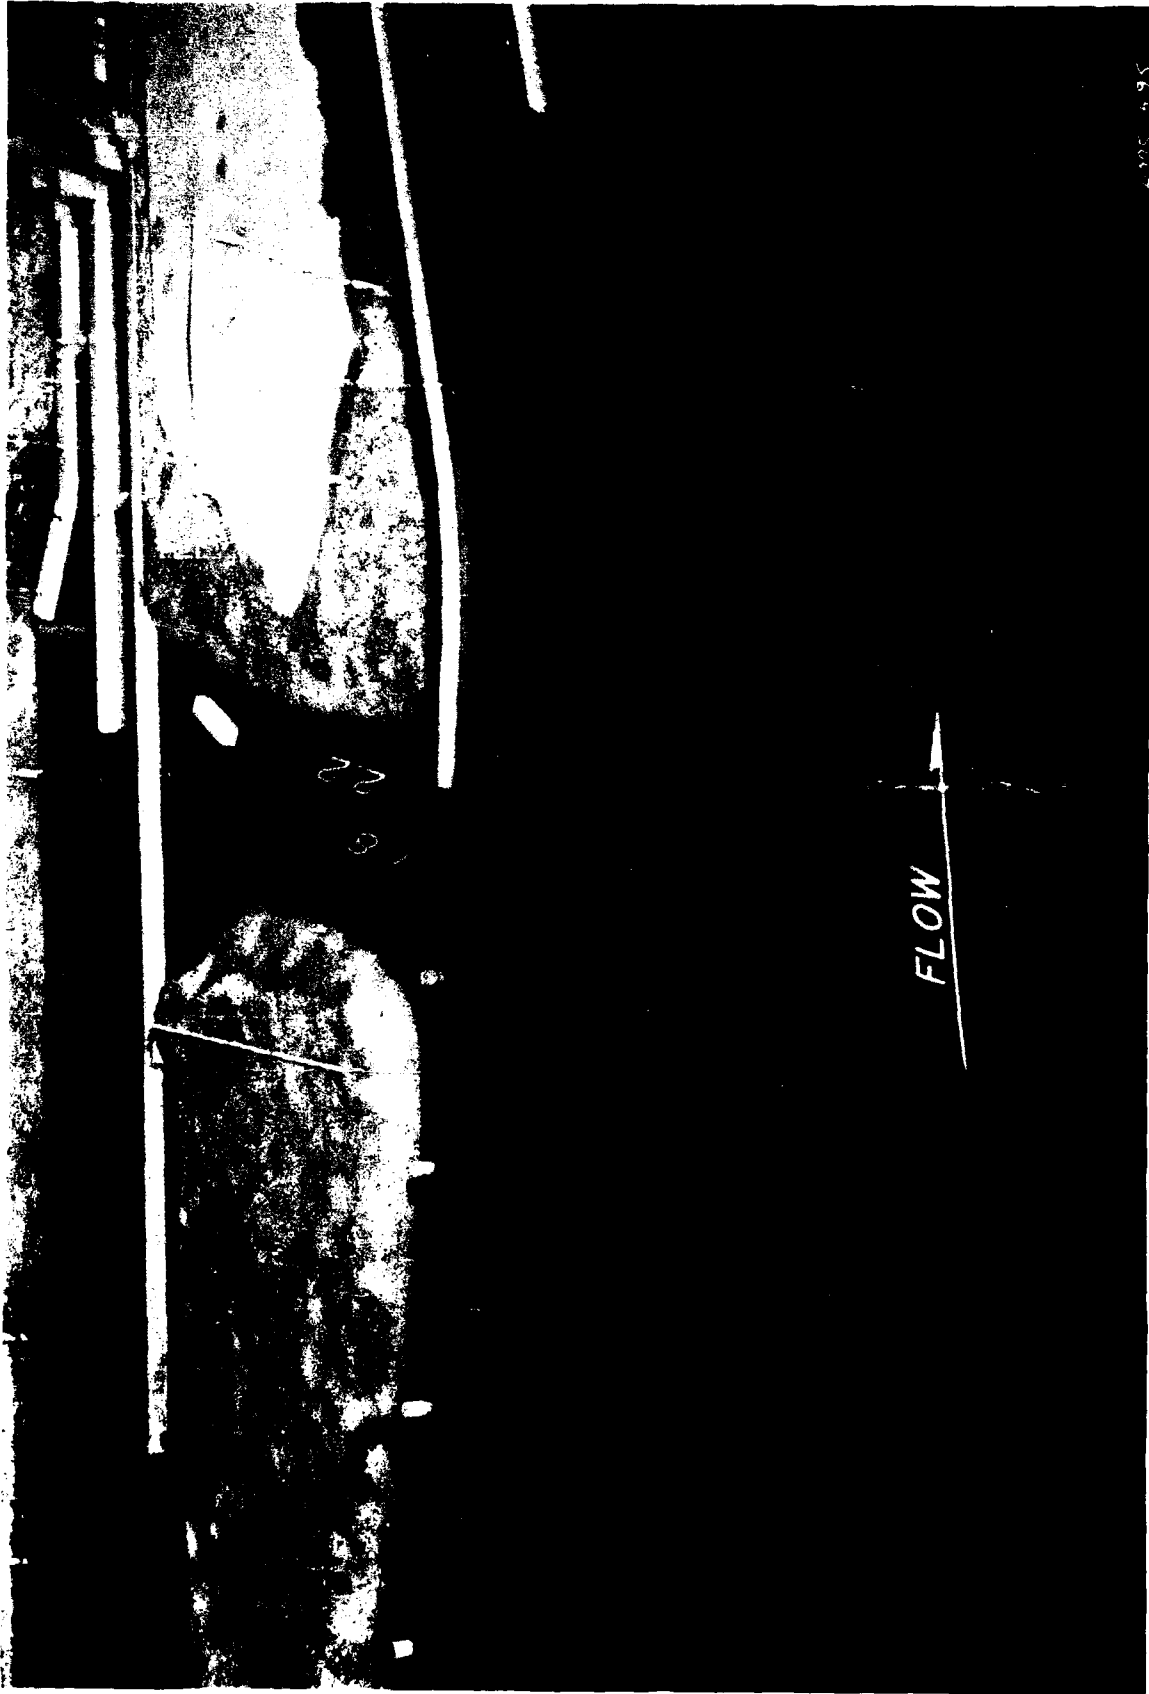
Photo 32. Plan E-10 modified, Scheme 9. Discharge 16,000 cfs, upper pool el 538.0, lower pool el 515.0. Current velocities and dye patterns in the approach to the filling intakes resulting from filling the 1,200-ft lock in 8 min

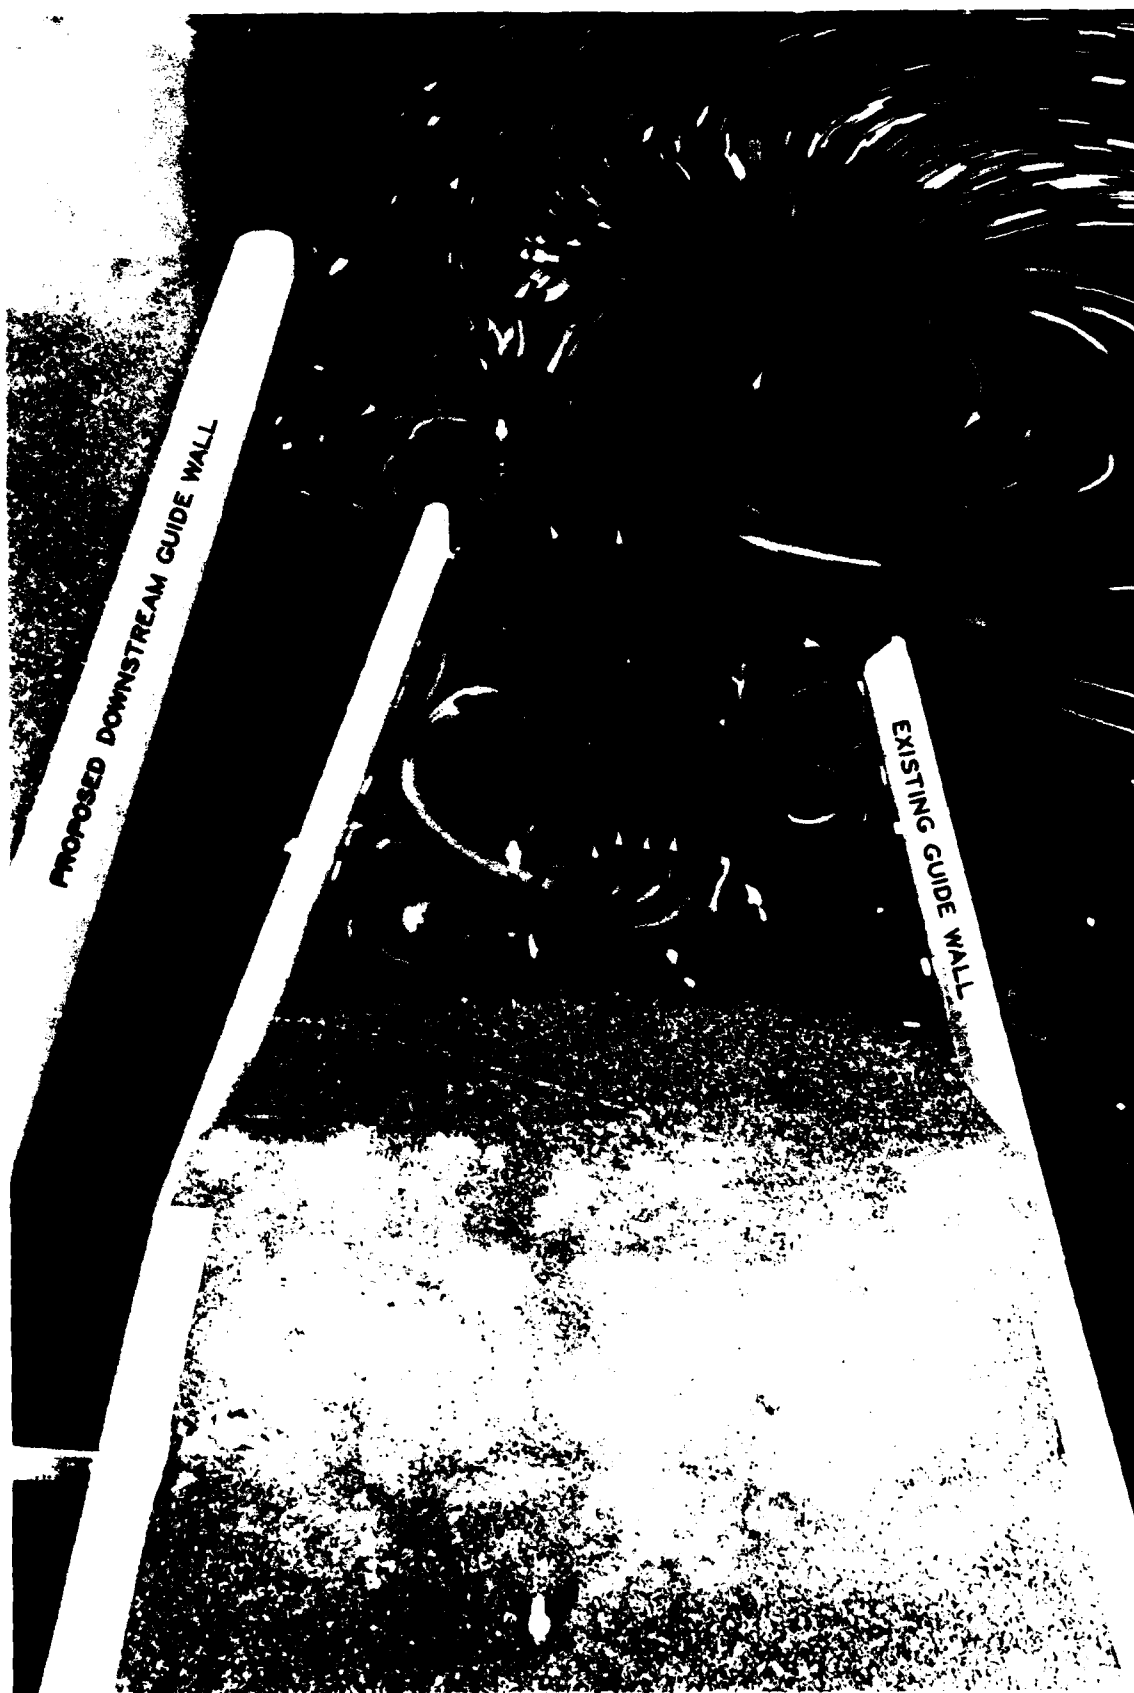
Photo 36. Plan E-4, Scheme 6. No river discharge, upper pool el 538.0, lower pool el 515.0. Dye pattern and superimposed arrows indicate direction of bottom currents during lock emptying in 8 min

76. Current patterns created during lock emptying with Plan E-4 are shown in Photos 36 and 37. These results indicate that there would be no appreciable currents in the lower approach to the new lock during lock emptying. A clockwise eddy formed downstream of the wing wall that extended into the approach to the existing lock. Maximum velocities in the eddy were as much as 2.1 fps. Current patterns created during lock emptying with Plan E-5 (Photos 38-40) indicate the same general trends as with Plan E-4. Maximum velocities in the eddy were about 2.1 fps and extended into the lower approach to the existing lock, about the same as with Plan E-4. There was no indication of any currents in the approach to the new lock. Lock emptying with Plan E-4 or E-5 had no adverse effect on navigation conditions in the lower approach to the new lock and very little effect on tows approaching the existing locks, even with no flow through the dam.

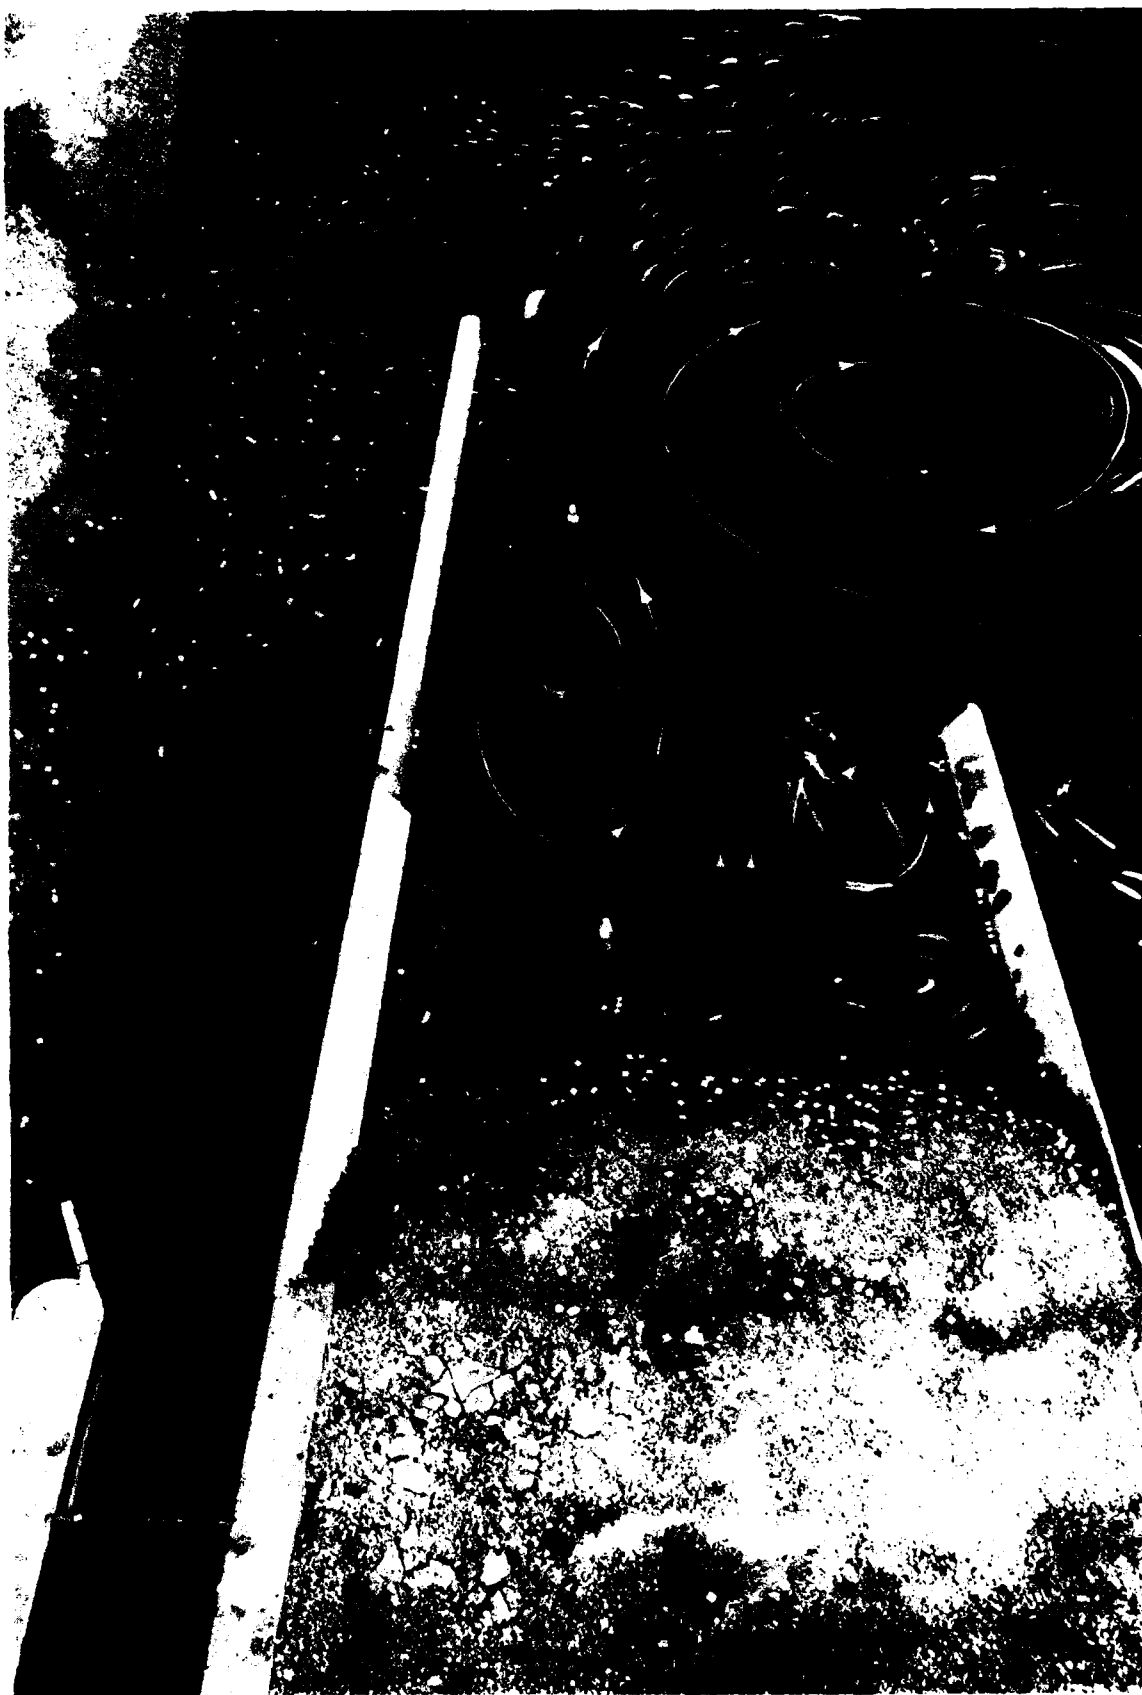
Photo 38. Plan E-5, Scheme 6. No river discharge, upper pool el 538.0, lower pool el 315.0. Dye showing current pattern developed during lock emptying in 8 min

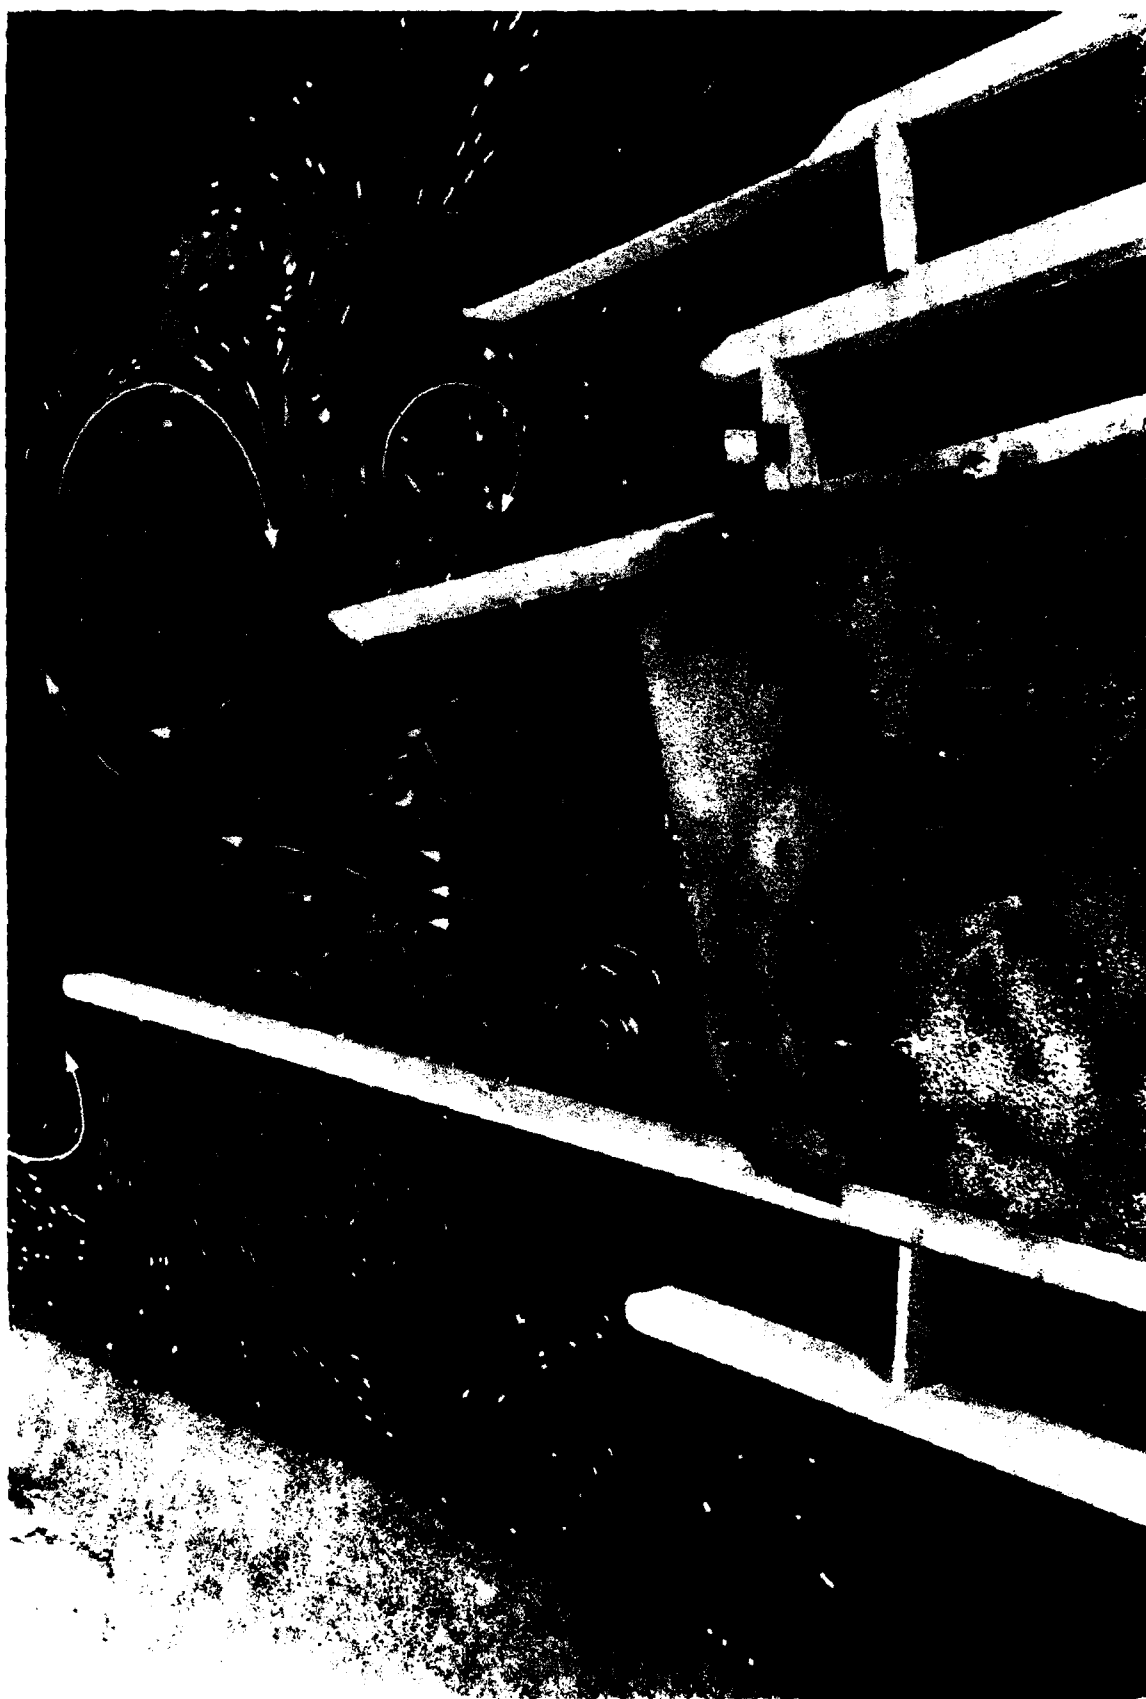
Photo 40. Plan E-5, Scheme 6. No river discharge, upper pool el 538.0, lower pool el 515.0. Current velocities obtained with floats submerged to a depth of 9 ft during lock emptying in 8 min

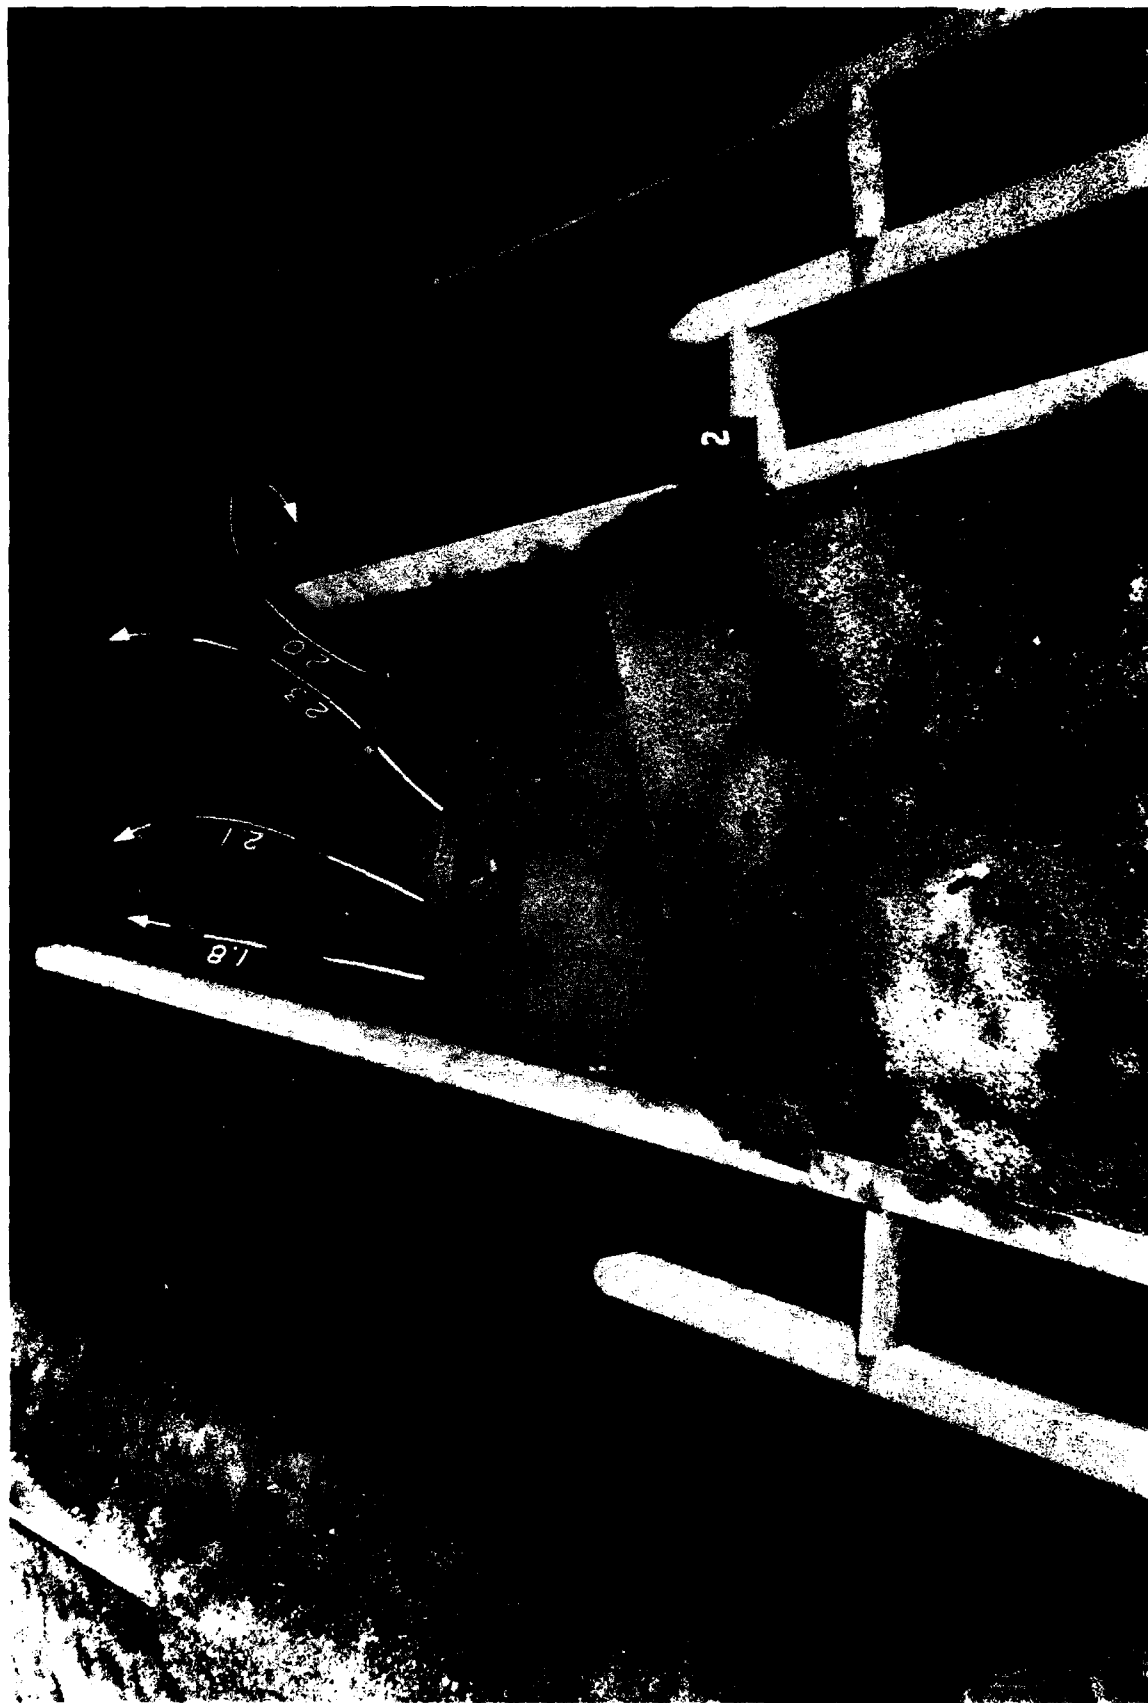
Photo 41. Plan E-7 modified, Scheme 7. No river discharge, upper pool el 538.0, lower pool el 515.0. Surface current and dye pattern during emptying both new locks simultaneously in 8 min. Note eddy in lower approach to existing lock

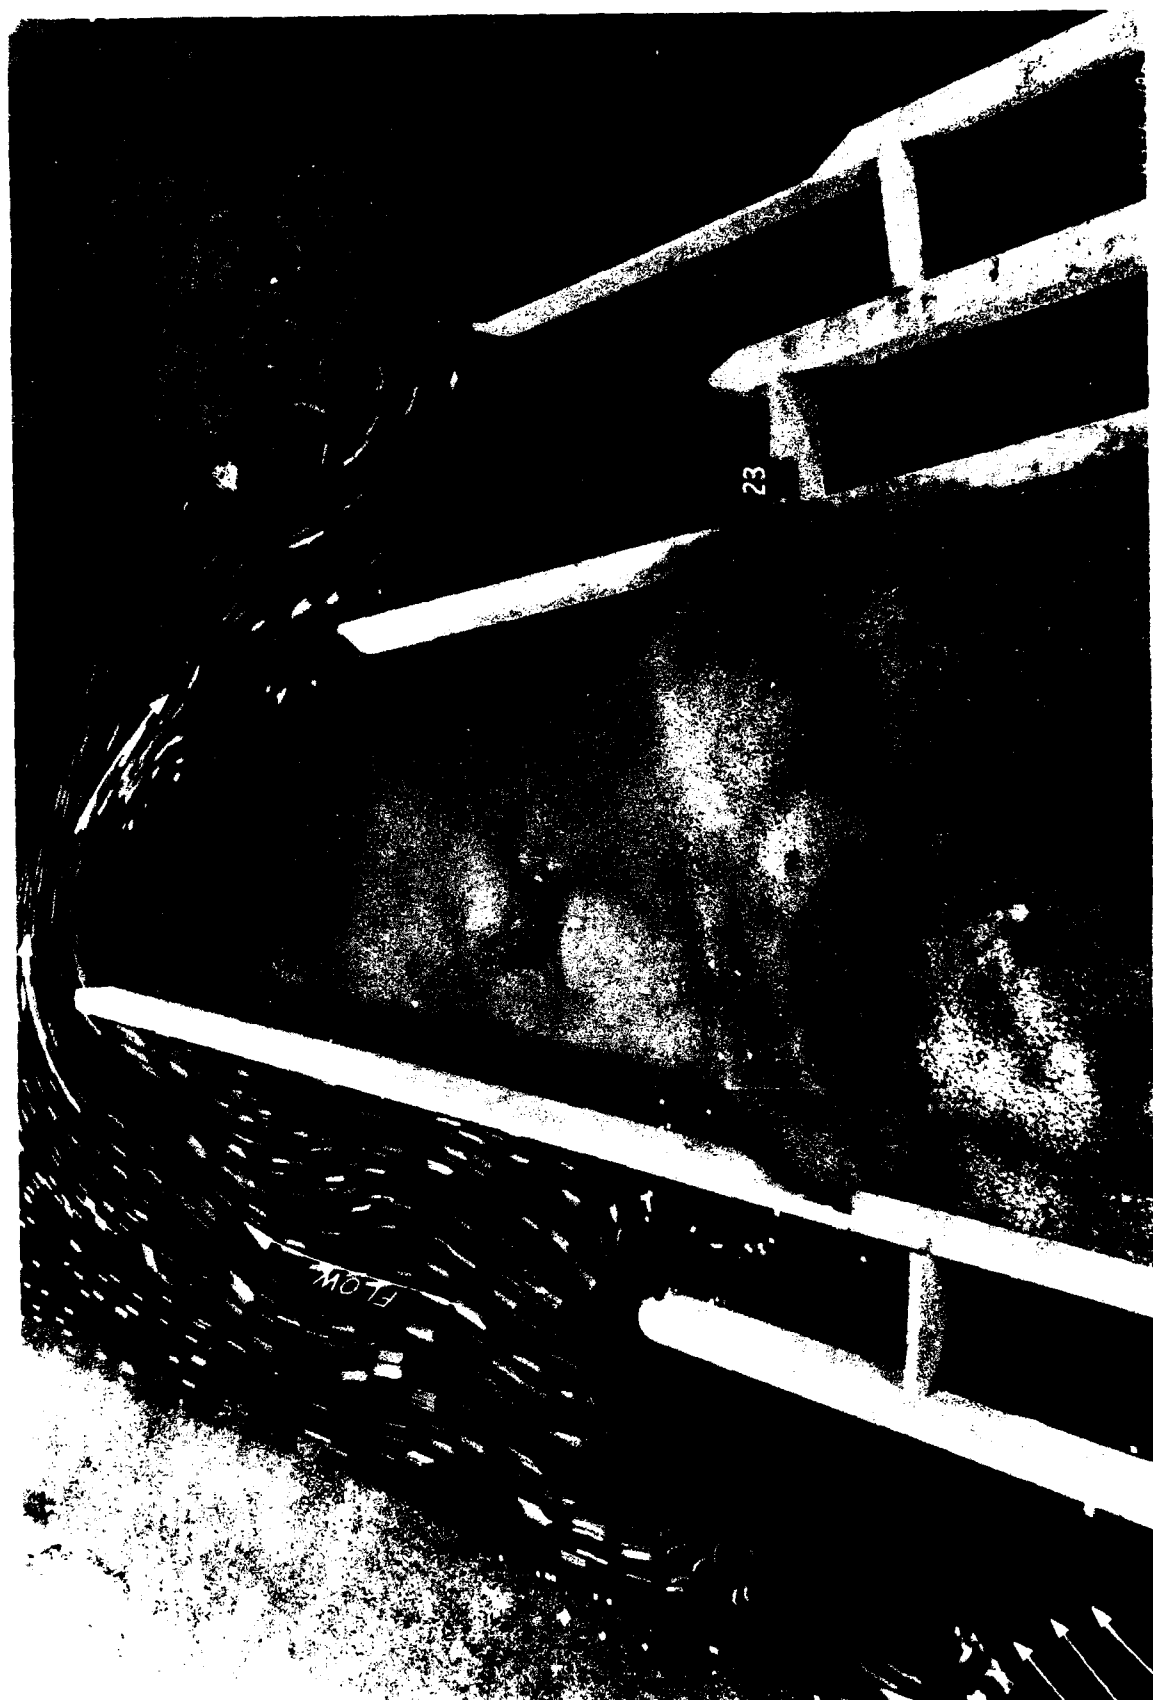
Photo 42. Plan E-7 modified, Scheme 7. No river discharge, upper pool el 538.0, lower pool el 515.0.  
Current direction and velocities resulting from emptying both the new locks simultaneously in 8 min

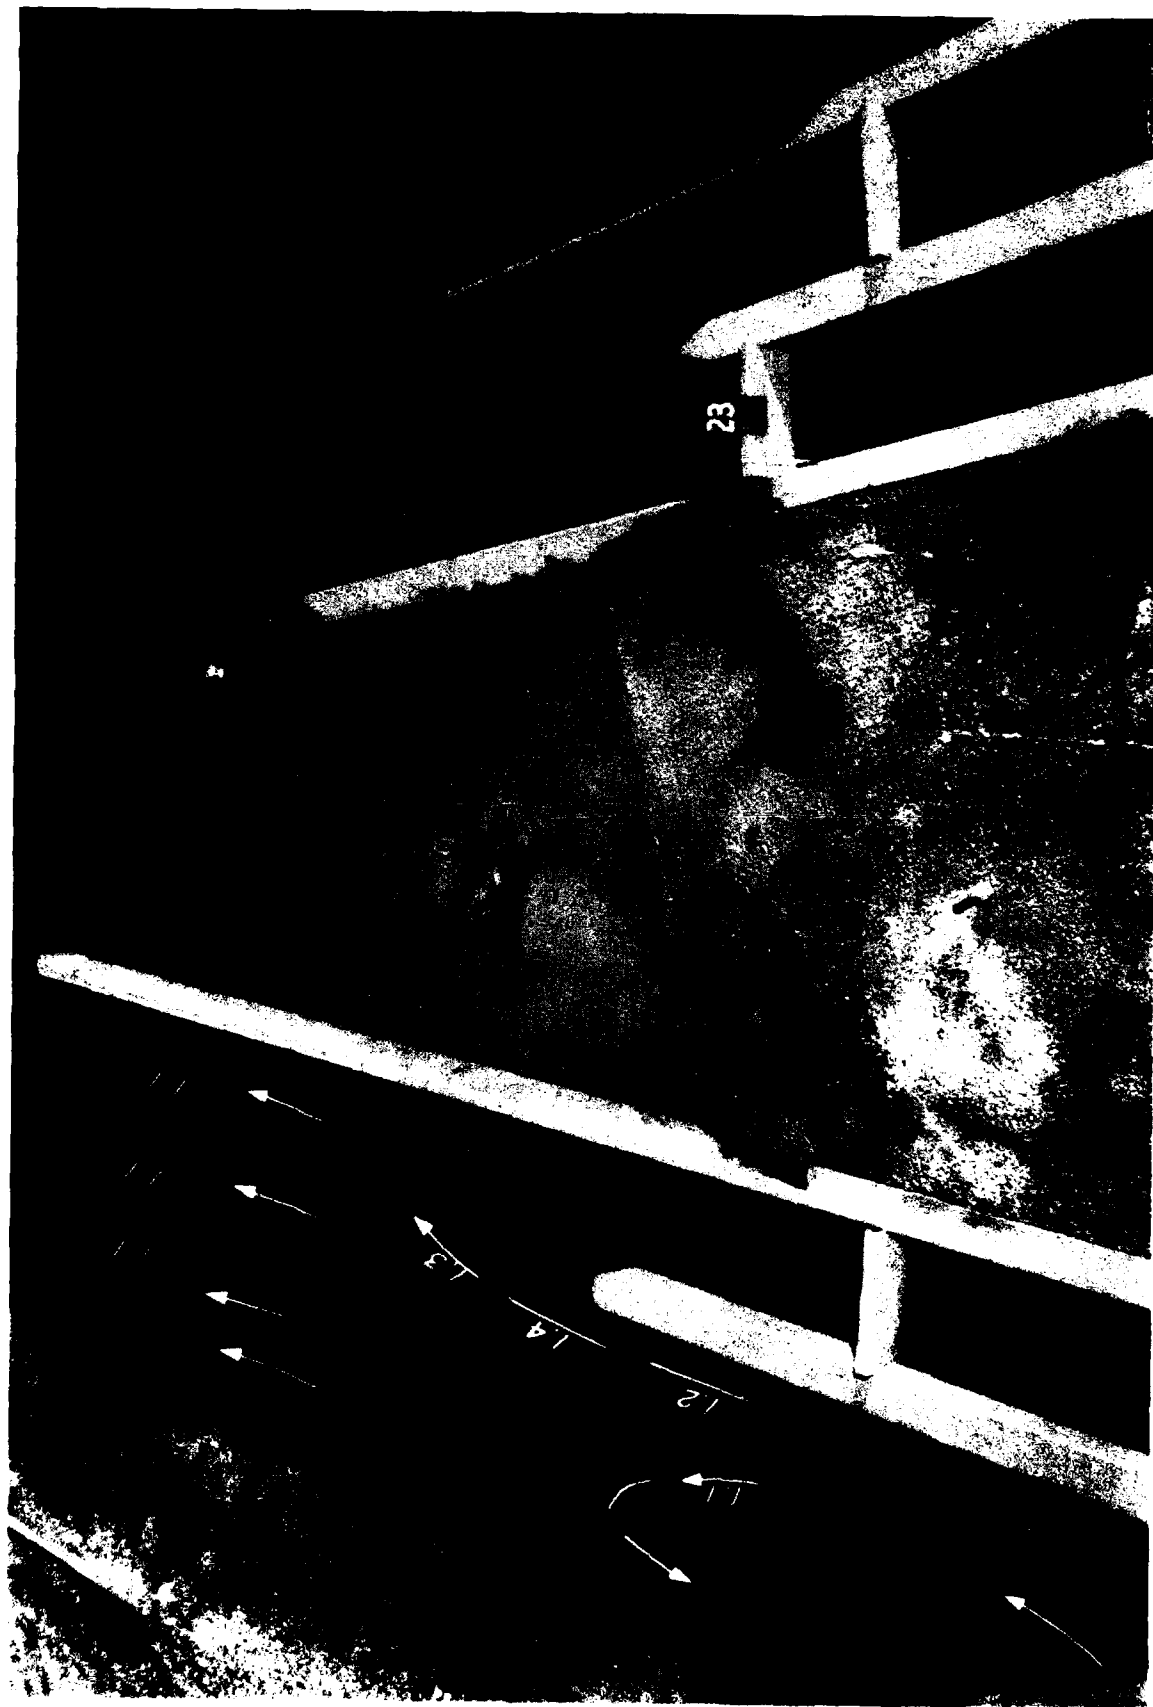
Photo 43. Plan E-7 modified, Scheme 8. No river discharge, upper pool el 538.0, lower pool el 515.0. Surface current and dye patterns during emptying the 600-ft lock in 8 min. Note the concentration near the end of the guide wall

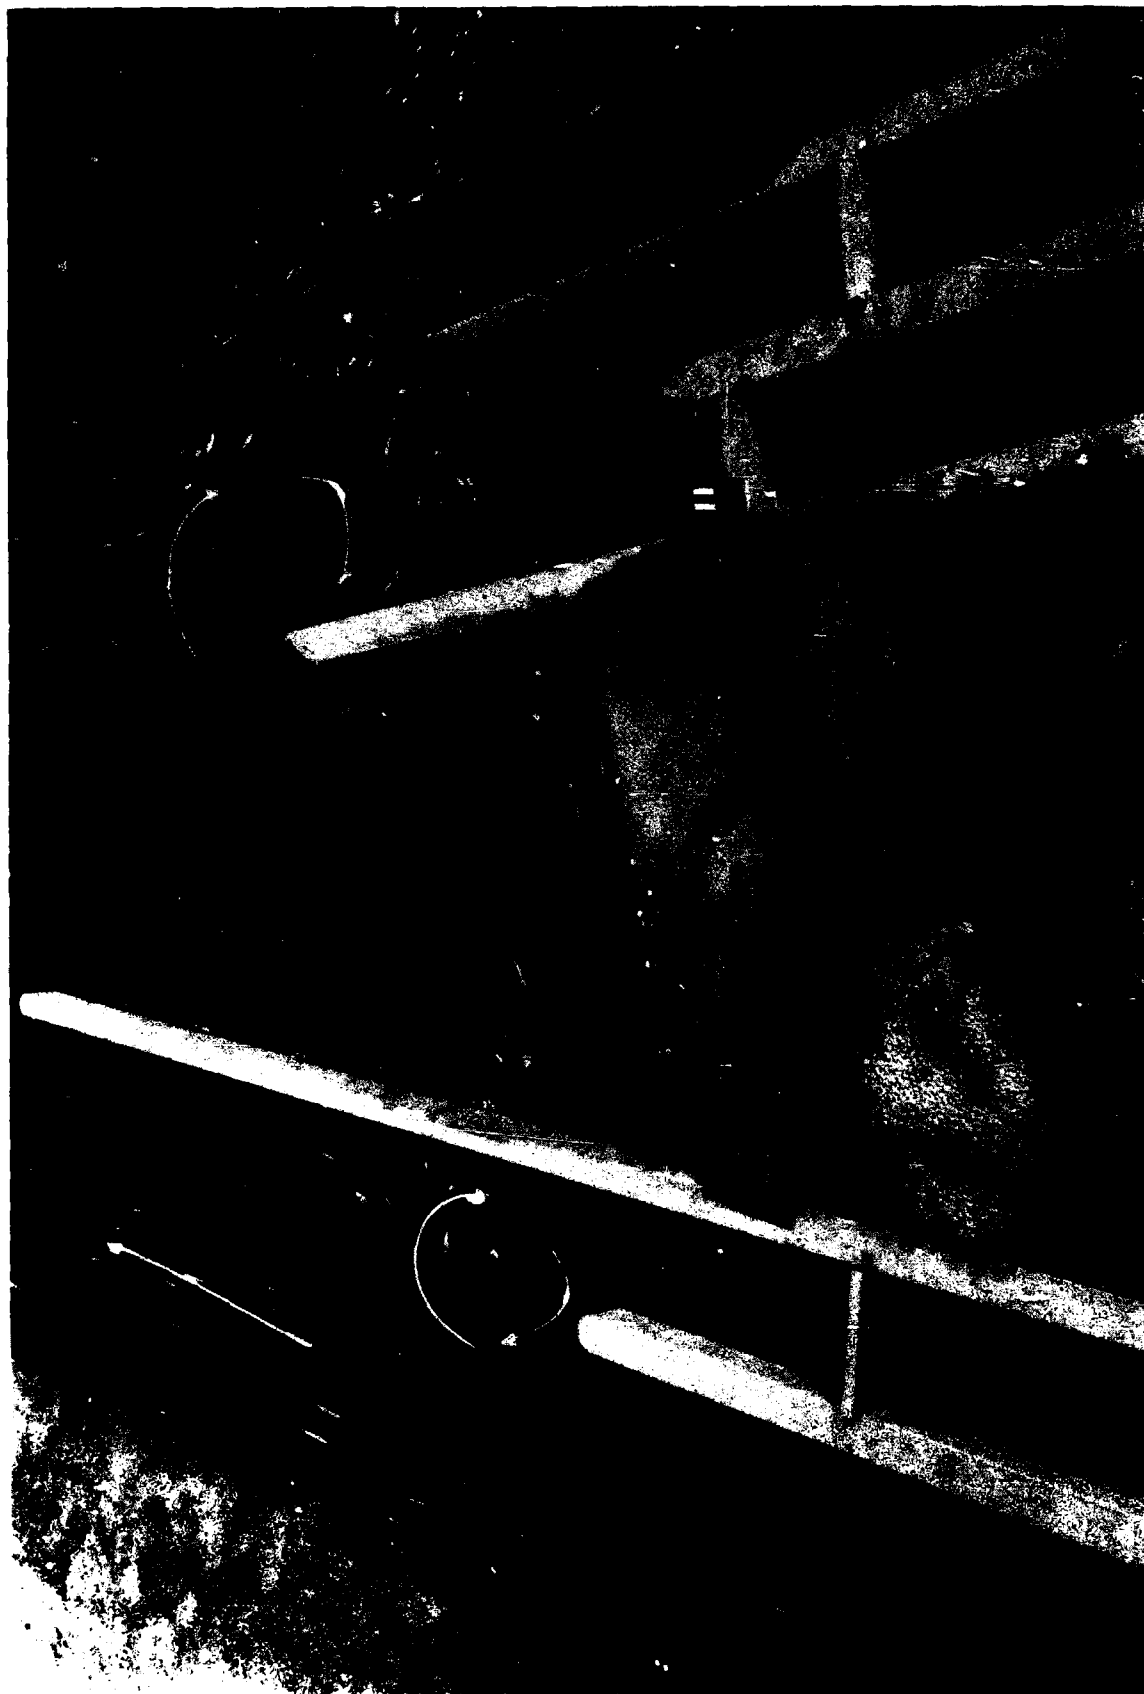
Photo 44. Plan E-7 modified, Scheme 8. No river discharge, upper pool el 538.0, lower pool el 515.0. Current direction and velocities in the lock approach resulting from emptying the 600-ft lock in 8 min
